# Smoke and Dye Testing Summary

## High Level Sewershed

Test ID	Test Type	Date Inspected	Company / Super.	Blower MH	Ground Condition	Notification Made?	Total Length
S1028-188	Smoke	7/22/2009	ADS/TM	S13AA_026MH	Dry	Yes	997.80

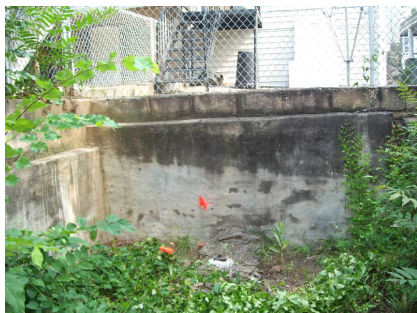
**Picture** \S1028-188-OB01-P01.jpg

**Comments** Smoke from service lateral under paved concrete in back yard. 2727 Riggs Ave.

**Comments** Back of house, 2727 Riggs Ave.

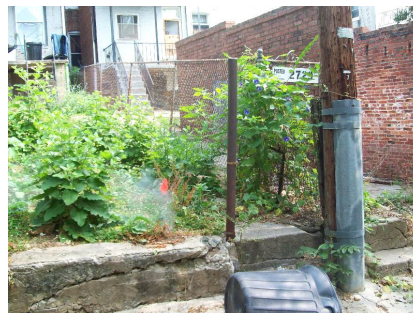
**Picture** \S1028-188-OB02-P01.jpg

**Comments** Smoke from above-grade cleanout (missing cap) in back yard. 2731 Riggs Ave.

**Comments** Back of house, 2731 Riggs Ave.

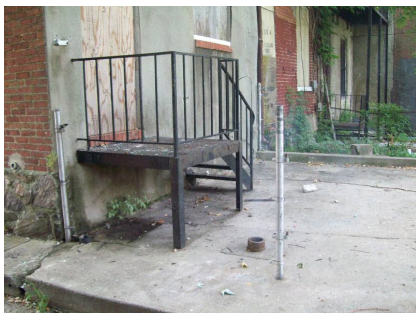
**Picture** \S1028-188-OB03-P01.jpg

**Comments** Smoke from above-grade cleanout (missing cap) in paved concrete in back yard. 1006 Dukeland St.

**Comments** Back of house, 1006 Dukeland St.

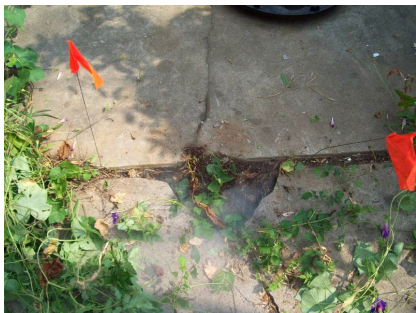
**Picture** \S1028-188-OB04-P02.jpg

**Comments** Smoke from service lateral under paved concrete in back yard. 2743 Riggs Ave.

**Comments** Paved concrete behind house, 2743 Riggs Ave.

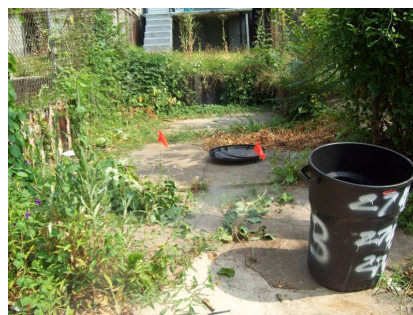
**Picture** \S1028-188-OB04-P01.jpg

**Comments** Smoke from service lateral under paved concrete in back yard. 2743 Riggs Ave.

**Comments** Back of house, 2743 Riggs Ave.

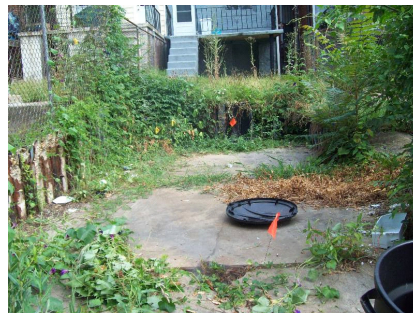
**Picture** \S1028-188-OB05-P01.jpg

**Comments** Smoke from service lateral in back yard at retaining wall. 2743 Riggs Ave.

**Comments** Back of house (flag in background), 2743 Riggs Ave.

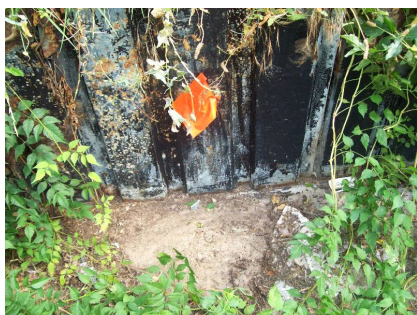
**Picture** \S1028-188-OB05-P02.jpg

**Comments** Smoke from service lateral in back yard at retaining wall. 2743 Riggs Ave.

**Comments** Back yard, 2743 Riggs Ave.
